NASA TECHNICAL MEMORANDUM

NASA TM X-64901

PERFORMANCE OF SOLAR SHIELDS

By Robert J. Schwinghamer
Materials and Processes Laboratory

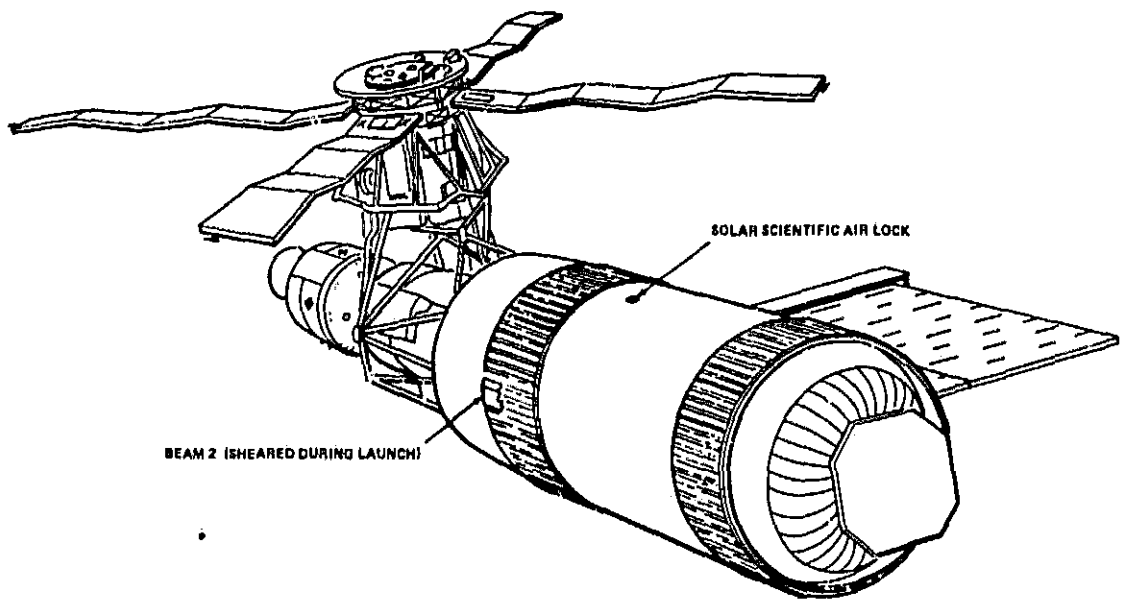
Figure 1. JSC parasol external configuration at ingress.

The Skylab external configuration (Fig. 1) is shown at the time of ingress by Astronauts Conrad, Kerwin, and Weitz, the Skylab I crew. At this point, the Solar Array System (SAS) beam had not yet been released.

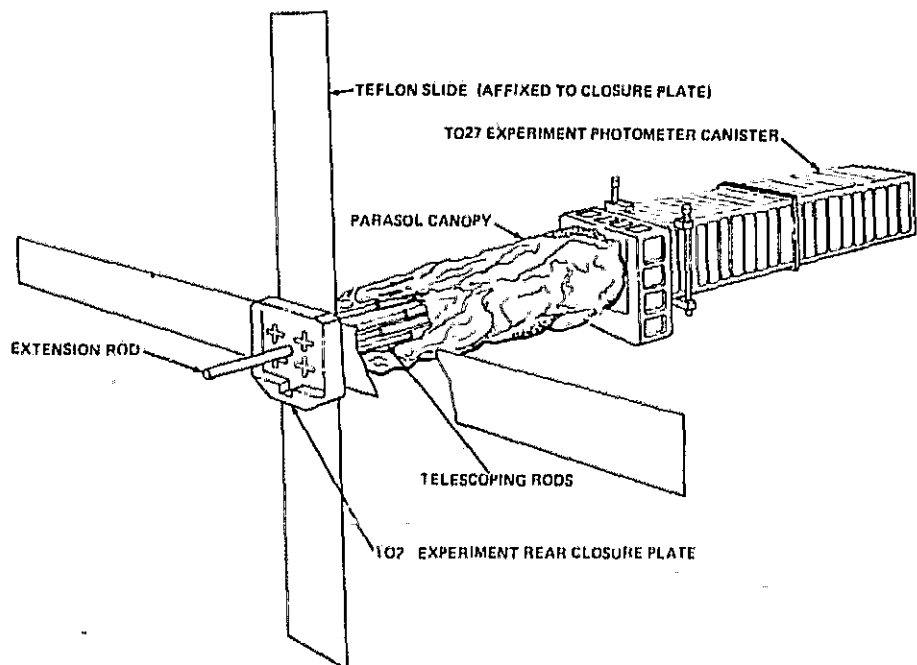
Figure 2. JSC parasol general packing arrangement.

The general packing arrangement can be seen in Figure 2. An existing TO-27 canister was employed.

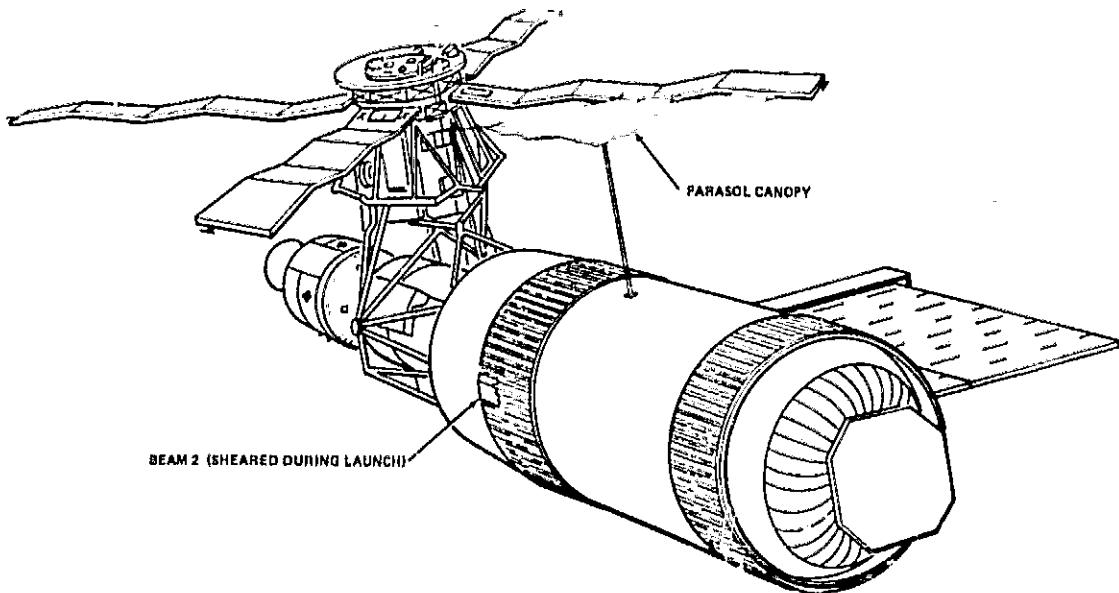
Figure 2. JSC parasol full extension and full deployment.

The canopy rods were projected to the maximum height of 7.3 m (24 ft.) above Skylab (Fig. 3). At this point the parasol deployment was completed, and the retraction to the final position near the OWS skin had not yet occurred.

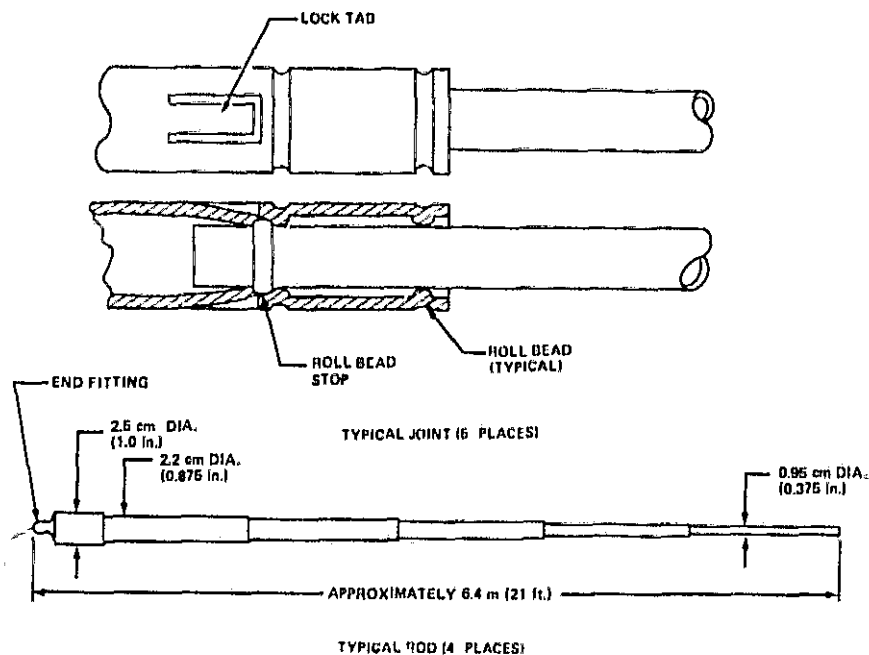
Figure 4. JSC parasol telescoping tube design.

A sketch (Fig. 4) of the unique telescoping tube locking mechanism which projected the corners of the 6 by 7.3 m (20 by 24 ft.) parasol is shown. The material used was 6061-T6 aluminum.

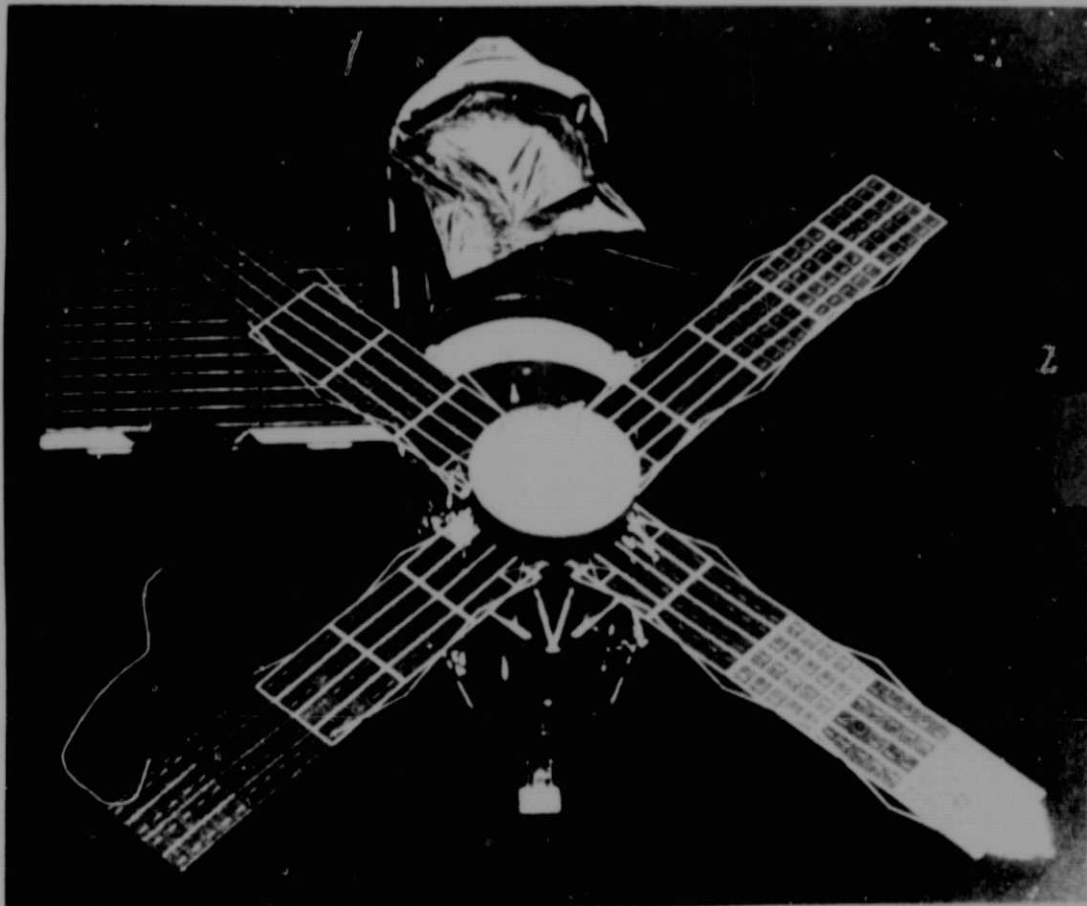
Figure 5. Skylab in deployment parasol configuration.

An actual photo (Fig. 5) was taken as the Skylab I crew left Skylab prior to the visit of the Skylab II crew. This view shows the incomplete coverage which resulted. The implications of this reduced shielding will be treated in more detail later.

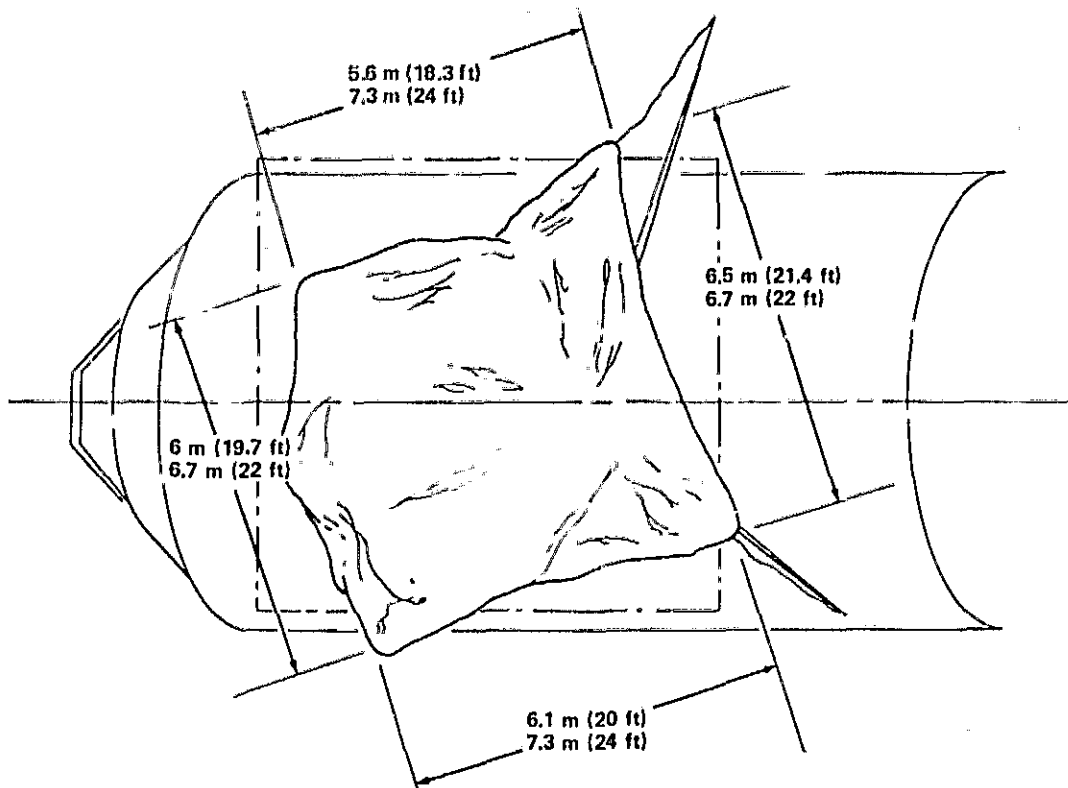
Figure 6. JSC parasol coverage comparison (actual vs. planned).

parasol to the original position, they did so, and no further attempts to use the rotation design feature of the parasol were ever made. The sketch (Fig. 6) shows the planned versus the actual coverage attained by the parasol.

After the JSC parasol was deployed on May 27, 1973, the internal temperatures decreased 16.7°C (30°F) in two days. The crew, however, observed that the shield did not completely open, and a day after the deployment, flight data began to differ from that predicted analytically by the thermal model. During the SL-1/SL-2 storage period the temperature reached 36.7°C (98°F) during a high Beta angle period. During departure of Skylab II crew, fly-around photos confirmed that the actual shade coverage was only 75 percent (Fig. 6).

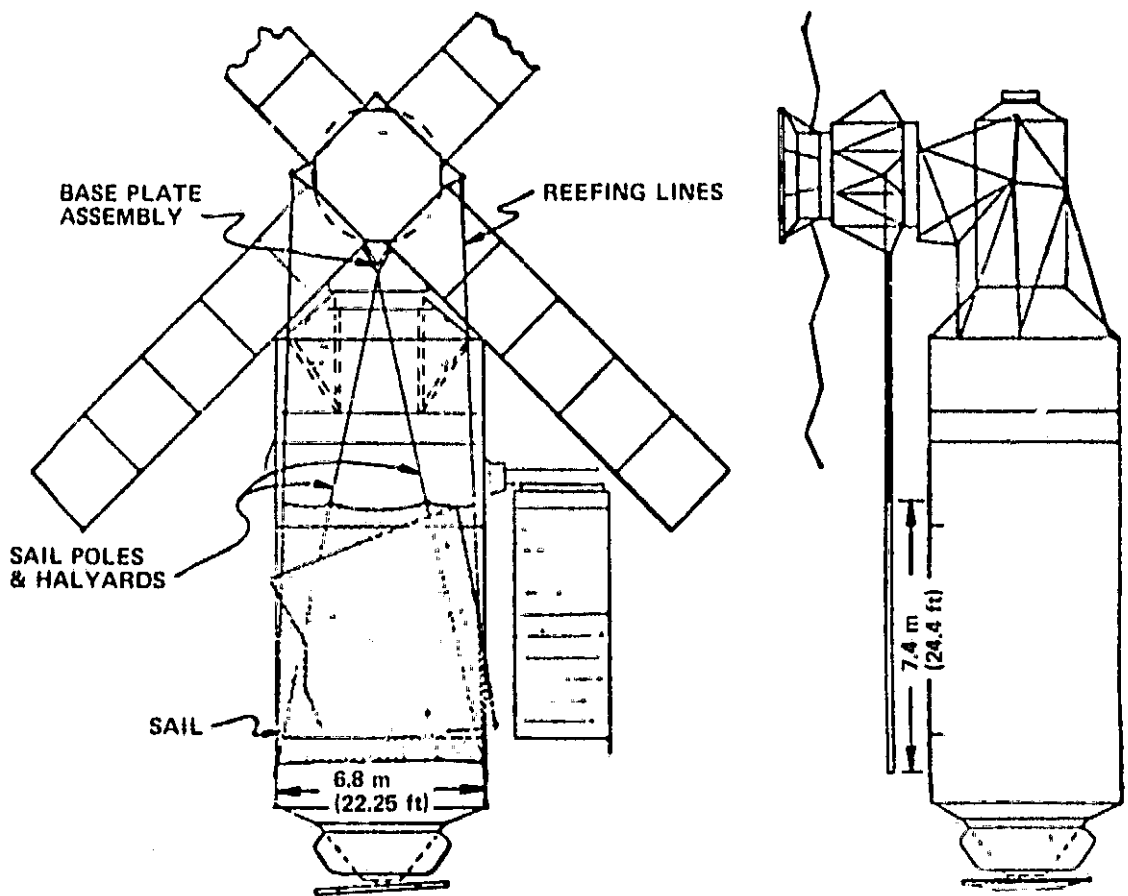
Figure 7. MSFC SAIL II arrangement.

The MSFC SAIL II was designed to provide a 6.8 by 7.4 m (22.25 by 24.42 ft.) thermal shield, or sunshade over the exposed goldized Kapton external skin of the OWS. This thermal shield required EVA, which was performed by the Skylab II crew consisting of astronauts Garriott and Lousma, while Commander Bean directed the operation. The SAIL design permitted either solo deployment, or allowed deployment over the existing JSC parasol, which was the solution finally adopted.

The MSFC SAIL II hardware included twenty-four 6061-T651 aluminum pole sections, each 1.5-m (5-ft.) long, which when coupled, provided two poles 16.8-m (55-ft.) long. Each pole connection had a twist lock arrangement featuring an extremely low temperature silicone "O" ring (SE-5211) which

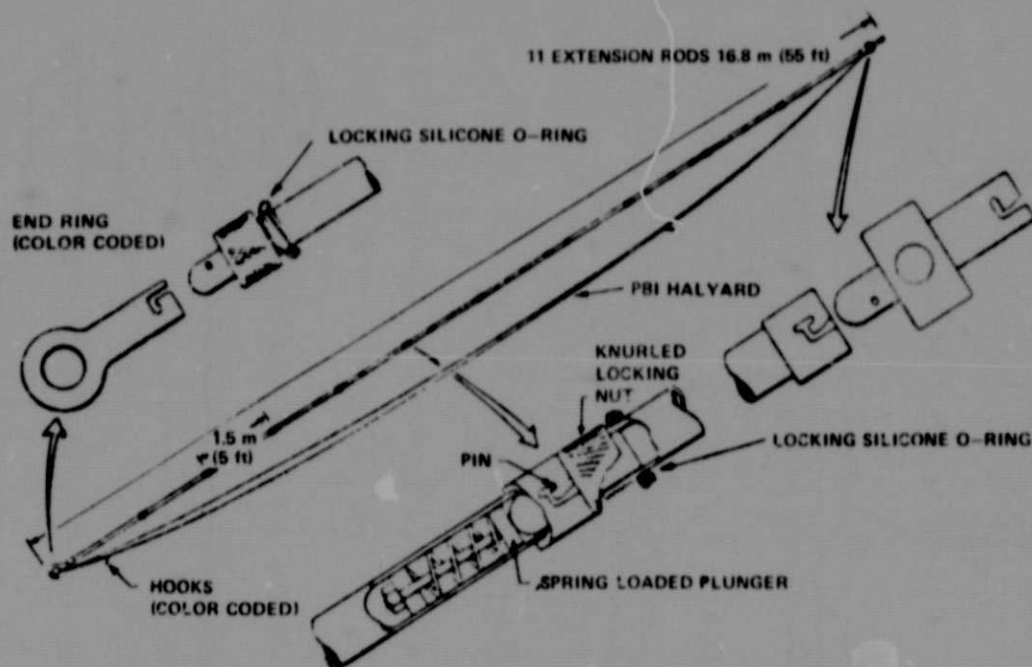
Figure 8. SAIL pole design details.

Design details of the SAIL poles are shown in Figure 8. In testing, it was found that the knurled nuts tended to back off and work loose. Special locking O rings were designed and manufactured to prevent this.

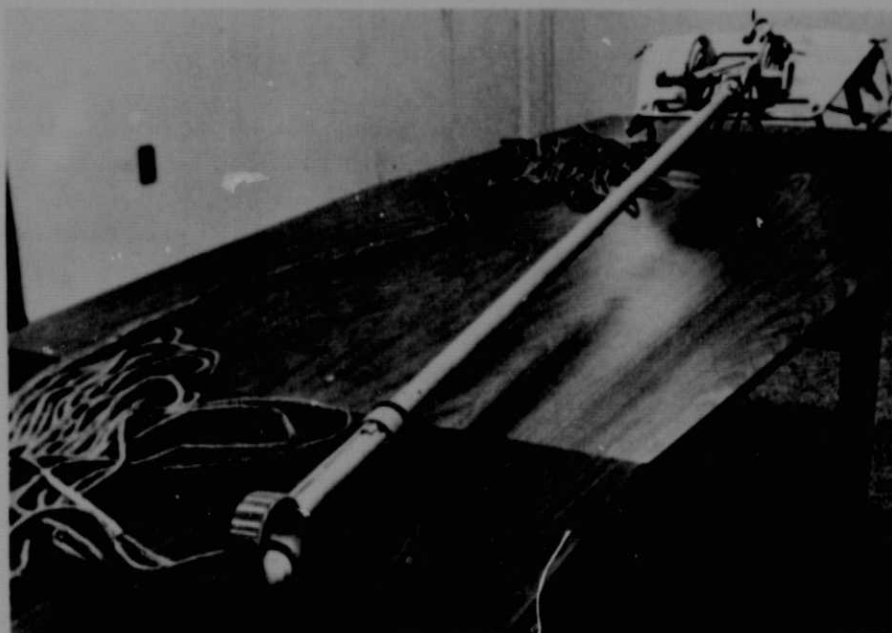
Figure 9. MSFC SAIL II pole baseplate with typical pole section, pole end-eye and PBI halyard rope.

The pole baseplate (Fig. 9) shows only one of the pole sections inserted. A typical eyed-end fitting and the PBI halyard rope can be seen in the foreground.

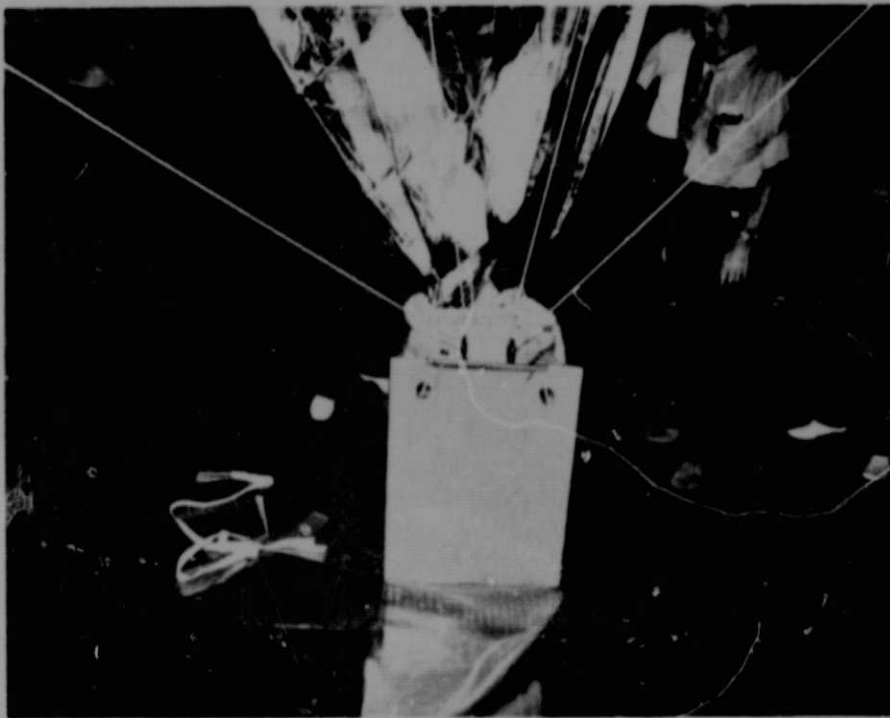
Figure 12. SAIL deployment from beta cloth bag test.

A SAIL undergoing a deployment test (Fig. 12) is shown in which the flow of the SAIL material from the bag was being checked. This view is from the OWS side, and the white S-13G material faces the deployment test engineers.

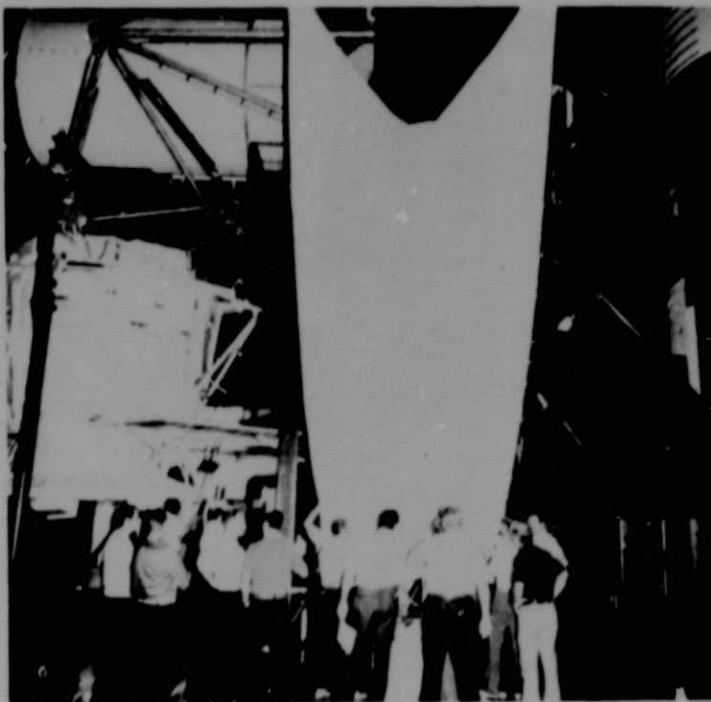
Figure 13. Final backup SAIL deployment and Skylab II crew training exercise.

A full scale deployment test (Fig. 13) was conducted at MSFC. This was the final check on a backup SAIL to determine positively that there would be no sticking of the thermal control surfaces during deployment. This was also the final deployment orientation session for the Skylab II crew, who finally deployed the SAIL on Skylab.

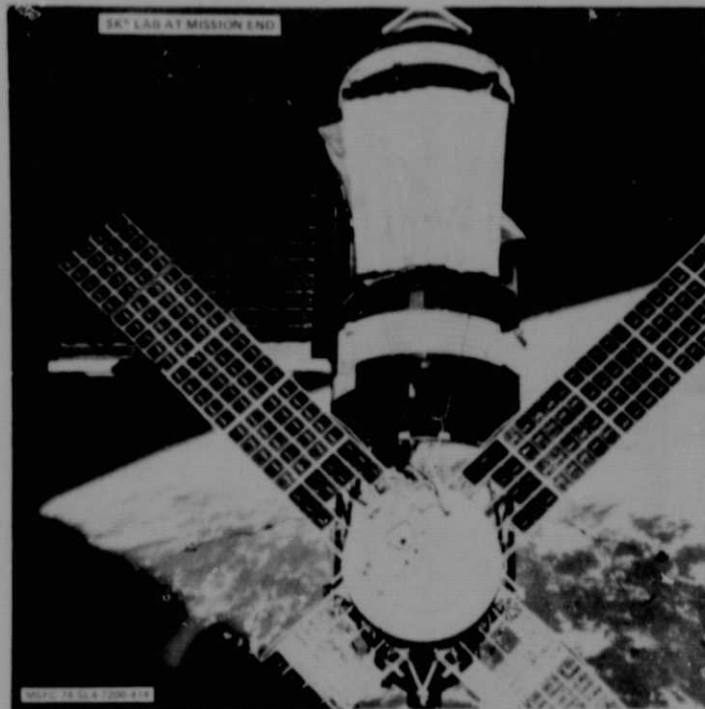
Figure 14. MSFC SAIL II deployed on Skylab.

Figure 14 shows the deployed MSFC SAIL II. The material "memory" characteristic and evidently a slight excess of material caused some slight accordioning of the deployed SAIL. Subsequent measurements in the plan view, of photographs taken during the Skylab III crew fly-around, showed that 89 percent of the expected coverage had been attained. In retrospect, it is highly probable that the 76 day stowage period in the packed, partially evacuated condition, caused some material set, but in the brief 10 day design, development and test period available before the launch of the Skylab I crew, no meaningful "accelerated" aging, or "memory" tests could be devised. Short time memory and aging tests of witness specimens did not exhibit the accordioning tendency. The general performance of the thermal shields will be discussed next.

It turned out that, like the parasol, the sail was also incompletely deployed, and only 89 percent of the OWS sidewall was covered. This was due largely to creases in the sail which refused to flatten out completely after the long storage period experienced before deployment (76 days in the folded condition). Fly-around photos indicated also that more "stretch" could possibly have been employed by slightly different design. While neither of the shields was perfect, the combination of the two did the job nicely.

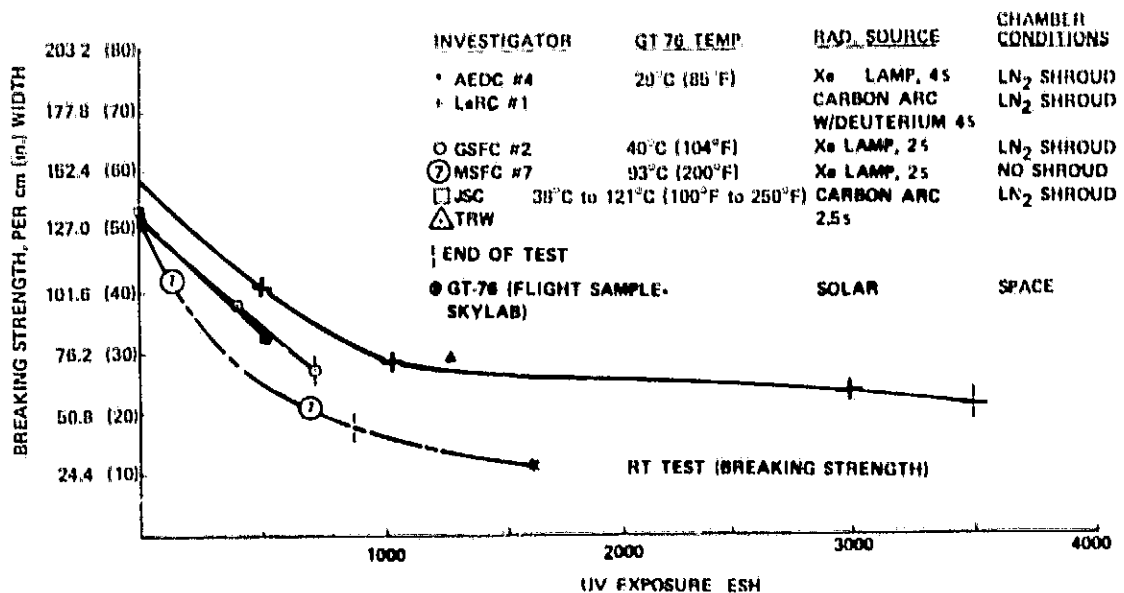
Figure 15. GT-76 room temperature breaking strength per centimeter (inch) of width vs. UV/vacuum exposure in equivalent sun hours (nylon to sun, warp direction).

The general trend of degradation of the GT-76 material breaking strength (Fig. 15) is shown in the warp (weakest) direction with continued UV/vacuum exposure as determined in the ground tests. Initially, this was considered quite alarming because the minimum strength required just wasn't known.

Dynamic structural analyses of the flapping of the parasol from the TACS firing finally concluded that 5 pounds-per-inch of width strength would be adequate to prevent tearing, but there was great reluctance, in general, to allow that limit to be approached. The 4000-hour data point shows the result of a measurement taken on a sample of GT-76 parasol material returned from Skylab. This point shows slightly higher strength remaining than the projected curves of the ground based data would imply. Almost all the ground test UV/vacuum test

data showed a tendency to be slightly more severe than the actual orbital condition. This could only be concluded in retrospect, however. Since UV source and intensity, substrate temperature, and chamber cold wall arrangement were influential factors in the ground test data; actual test conditions were carefully noted so that flight data comparisons could be made later. Flight samples have given rise to continued tests regarding properties, which are still in progress at the time of this writing.

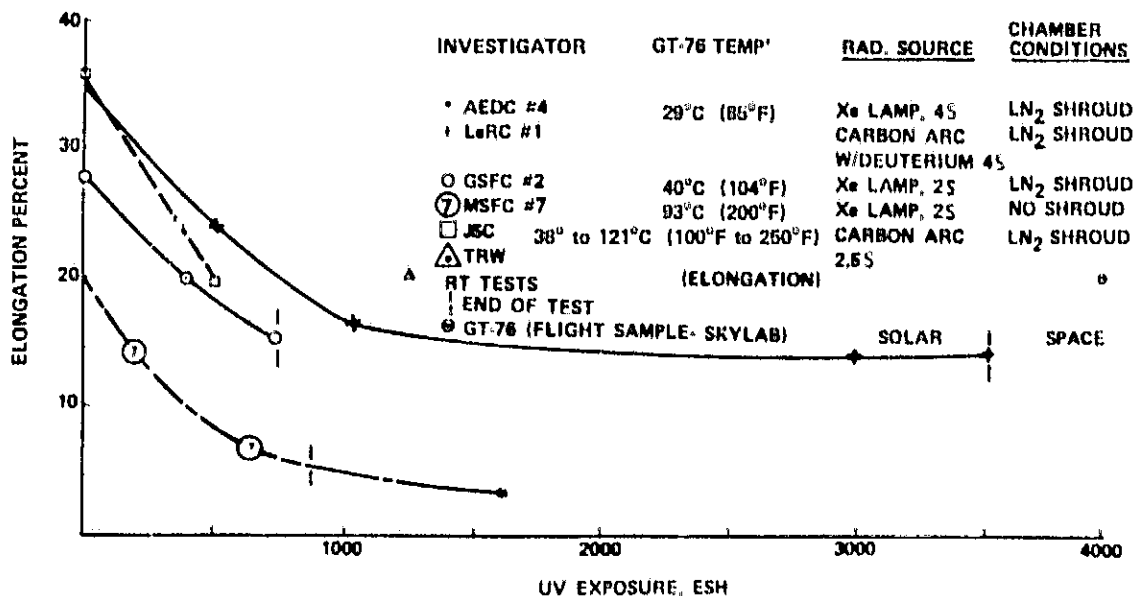
Figure 16. GT-76 room temperature elongation in percent versus UV/vacuum exposure in equivalent sun hours (nylon to sun, warp direction).

The effect of UV/vacuum degradation is shown (Fig. 16) on the GT-76 material room temperature elongation. Not unexpectedly, these data also showed an alarming tendency to decrease with increased exposure. This raised concern about the brittleness, primarily of the 2 1/2-mil ripstop Nylon and 1/2-mil Mylar of the GT-76 material being exposed to the sun.

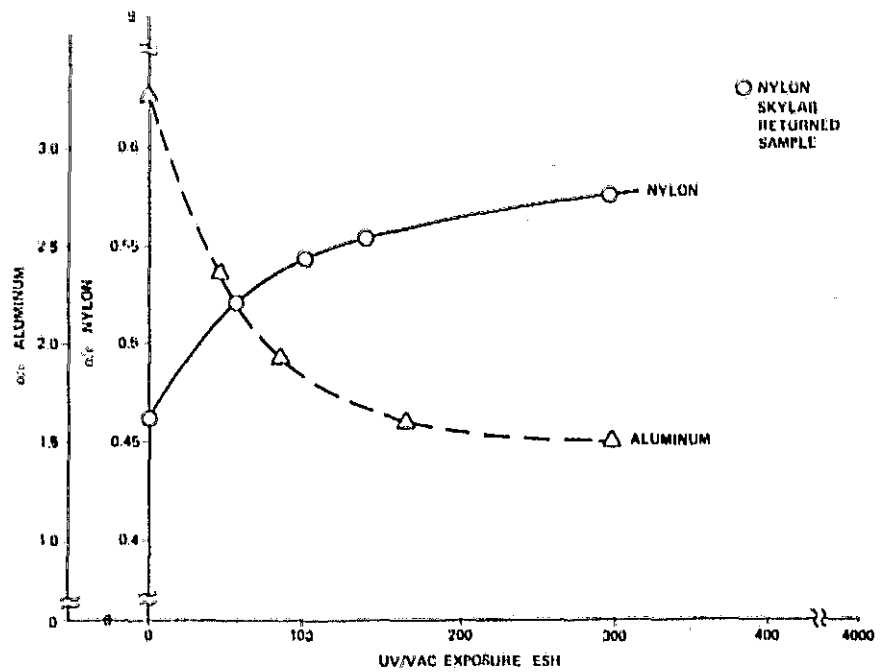
Figure 17. GT-76 α/ϵ versus UV/vacuum exposure (Nylon to sun).

The change in the α/ϵ ratio (Fig. 17) is shown for the GT-76 material. This ratio was obtained from ground based UV/vacuum testing. The isolated data point at the right is a returned Skylab sample data point.

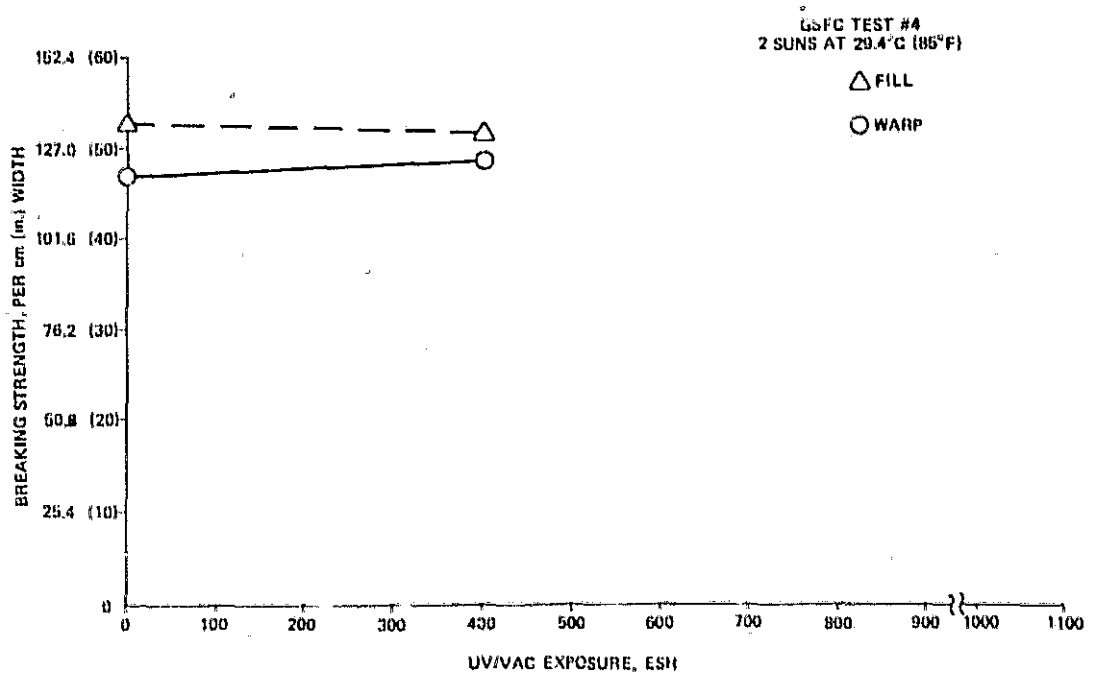
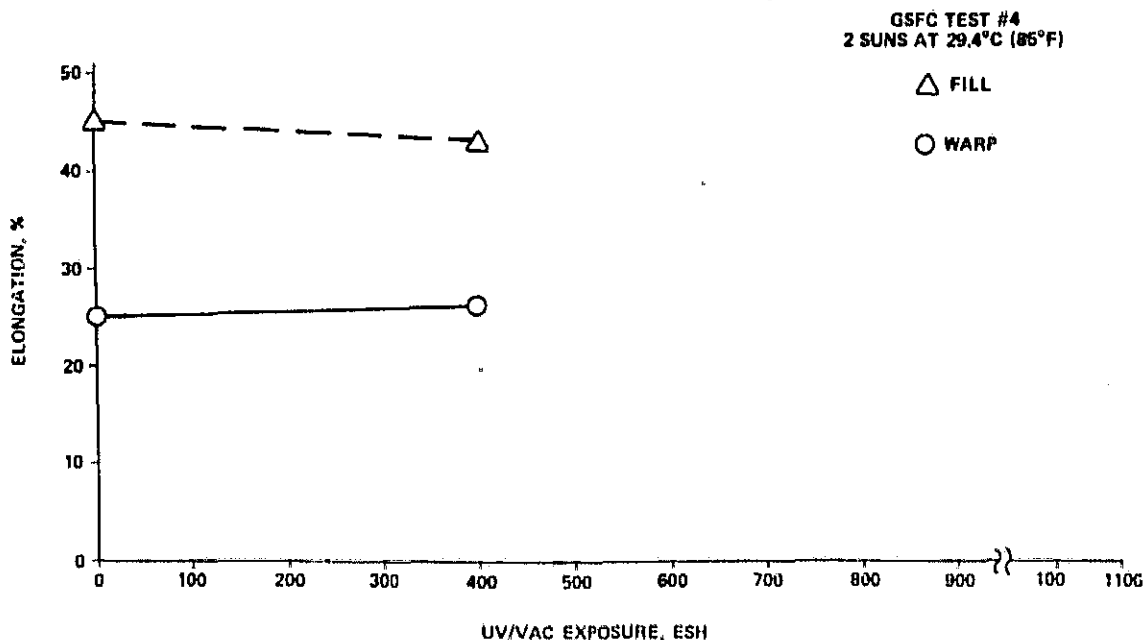
Figures 18 and 19 show the breaking strength and elongation of the MSFC SAIL II material tested to 400 ESH, after which the tests were terminated since no appreciable change was noted.

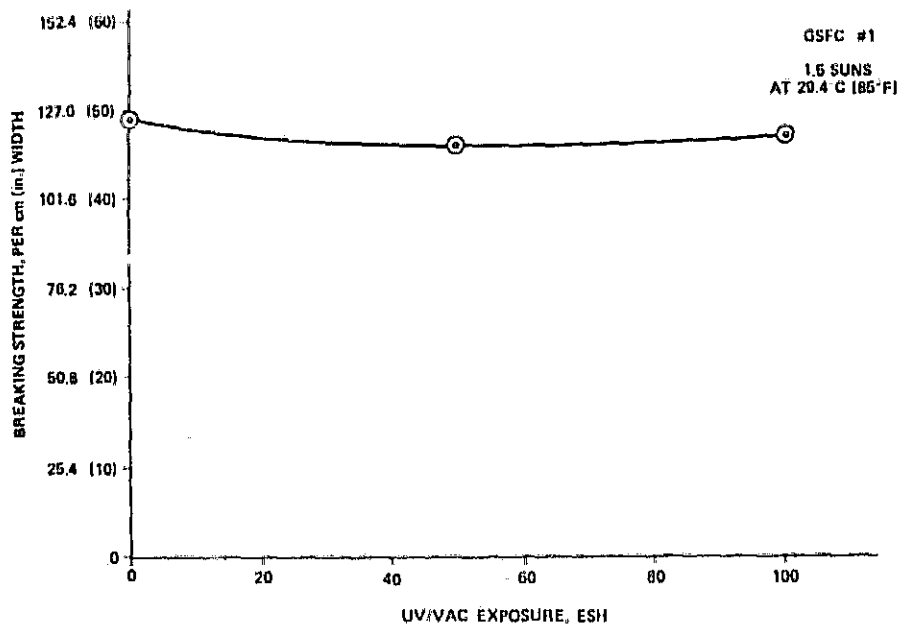
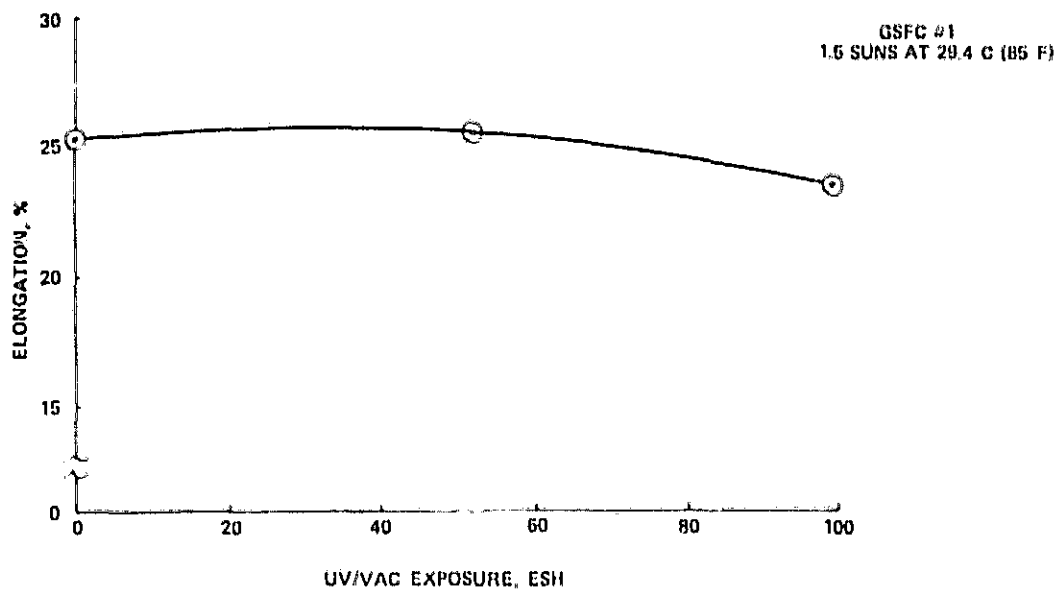
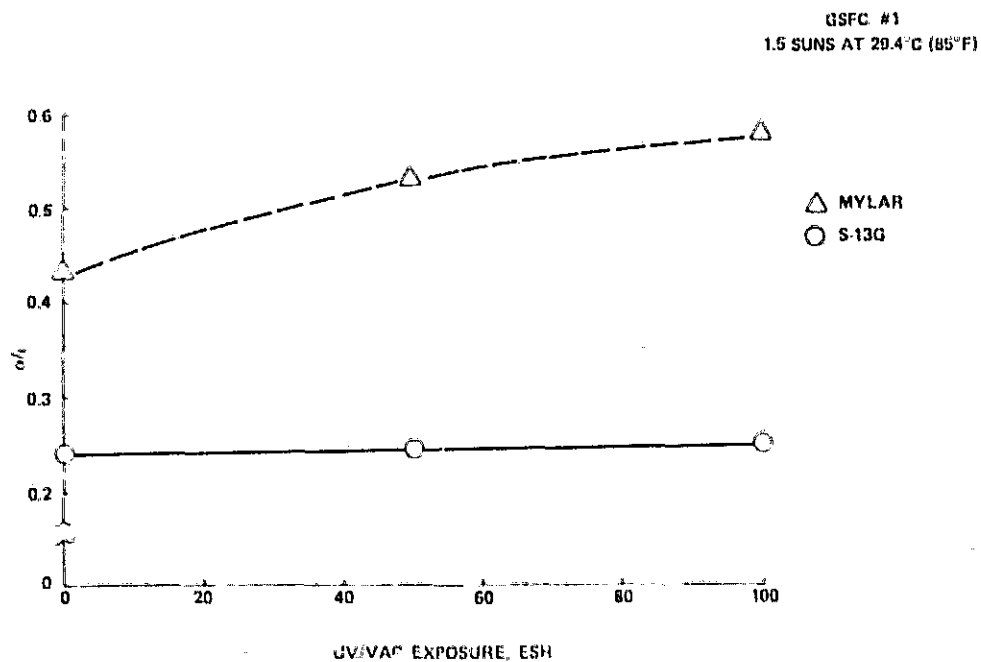
Figures 20, 21, and 22 show the breaking strength, elongation, and α/ϵ for the 100-hour UV/vacuum around test exposure. Interestingly, the strength and elongation properties of the S-13G coated MSFC SAIL II actually did not vary much with direction (warp or fill) of the Nylon ripstop weave orientation during the test because the coating tended to distribute the load more evenly. It turned out that breaking strength and elongation did not change appreciably either, for the Mylar backside irradiated SAIL material, but the α/ϵ of the Mylar did change as expected. The absorbance α changed from 0.18 to 0.27 while the emittance held constant. This shows again the great propensity for change of α/ϵ of Mylar in a UV/vacuum environment. At any rate these tests showed that fears about the damaging effects of earth's albedo on the backside of the MSFC SAIL II were groundless. Furthermore, it turned out that by deploying the sail over the parasol, the backside of the sail was well covered anyway. In addressing the potential UV/vacuum degradation of the MSFC SAIL II, S-13G UV/vacuum degradation data already existed at the time of the thermal shield all-out effort.

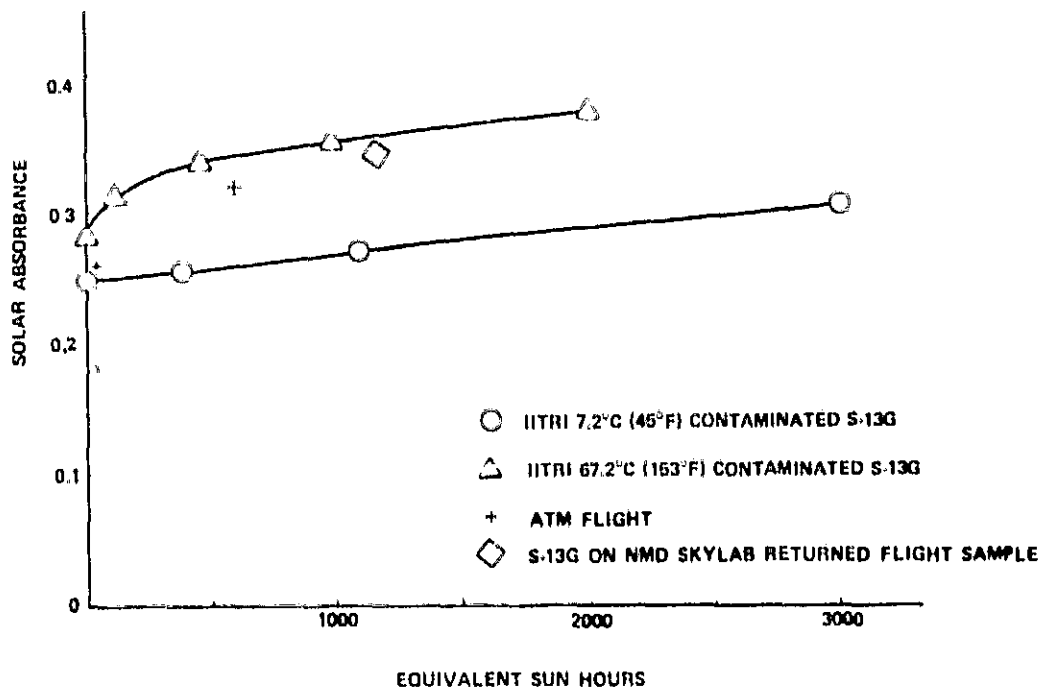
Figure 23. S-13G thermal control material α vs. ESH (ground and flight data).

Figure 23 shows absorbance (α) data from ITRI (Illinois Institute of Technology Research Institute) for contaminated S-13G at 7.2°C (45°F) substrate temperature and 67.2°C (153°F) substrate temperature, some early ATM flight data, and a data point from a Skylab returned sample of S-13G coated NMD material which

had "seen" 1176 ESH in orbit. It is interesting to note that the contaminated S-13G data from the ground testing tracked so well for the S-13G coating on the ATM, and the recovered flight sample. Earlier laboratory data on absolutely clean S-13G material showed very little degradation in 4000 ESH, but all indications are that contamination somewhat influenced the performance of the S-13G on the MSFC SAIL II, as well as other surfaces on Skylab which were painted with S-13G. Fortunately, the thermal performance of the S-13G material was still relatively good in spite of a degree of contamination.
